June 21, 2007
Project Number: SP070621

Re: Updated flood and slope hazard assessment of the northeast portion of District Lot 3668 in the Cheakamus River Valley, 15 km north of downtown Squamish, B.C.

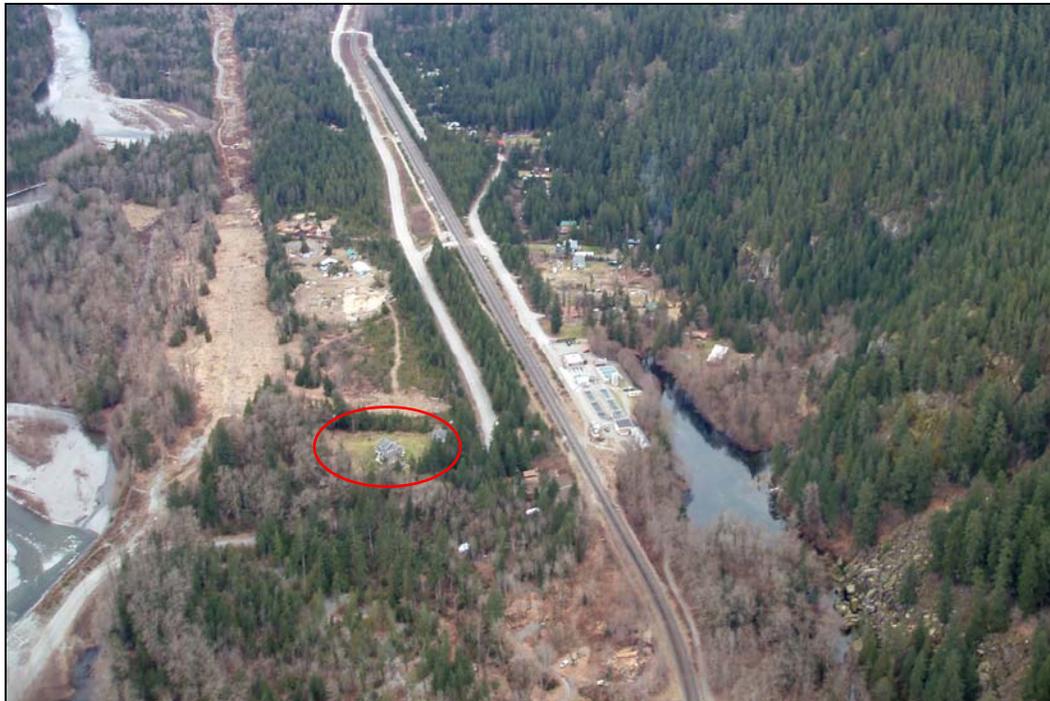
Figure 1: Overview photograph of the subject property (circled), looking north. The Cheakamus River is at left, and the CN Rail line goes through the centre of the picture. The CN track is located above the Q200 flood level.

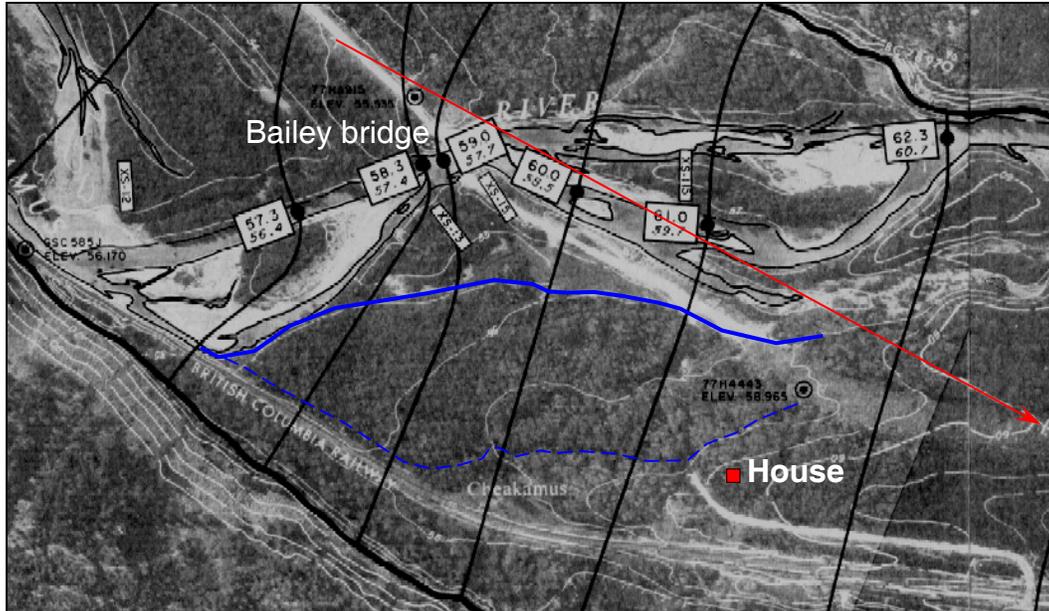
1. The 1999 report concluded that most of the property is on the floodplain of the Cheakamus river, and could be flooded during periods of high water flow. Specifically, at the main house on the north side of Paradise Valley road, flood waters could rise to an elevation of about 61.5 metres during a flood expected to occur on average once every 200 years (a so-called Q200 flood). Provincial legislation requires that inhabited areas of homes be above the 200 year flood level. In this case, the average ground elevation in the immediate vicinity of the main house is about 60.0 metres, and so inhabited areas of building need to be at least 1.5 metres above the ground.

Figure 1: A portion of the Cheakamus River floodplain map showing the location of the main house (red square) on Lot 3668. The arrow points north and is one kilometre long; for reference, note also the location of survey monument 77H4443. The solid blue line is the present long term stable river left (east) boundary of the Cheakamus River. The dashed blue line is a small overflow channel that would only be viable during major flooding events. The solid black lines at the top and bottom of the orthophoto mark the 200 year floodplain limit, and the crossing black lines are flood elevation contours that mark the elevation to which flood waters would rise during a flood expected to occur on average once every 200 years (Q200 flood).

2. In addition to inundation by flood waters, inhabited structures must also be able to resist the forces created by flowing water, and not unduly impede flood flow runoff during a high water event.
3. To deal with flood hazards, it was recommended that inhabited portions of dwellings in this area should be located at an elevation of at least 61.5 metres, and that a concrete foundation, or the equivalent, should be used to provide scour protection.
